**Intensive Cultural Resources Survey of the Proposed
Geneva Levee Rehabilitation Project
Geneva, Alabama**

Final Report

**Contract No. DACA01-97-D-0002
Delivery Order 0049**

**Brockington and Associates, Inc.
Atlanta Charleston Raleigh
2002**

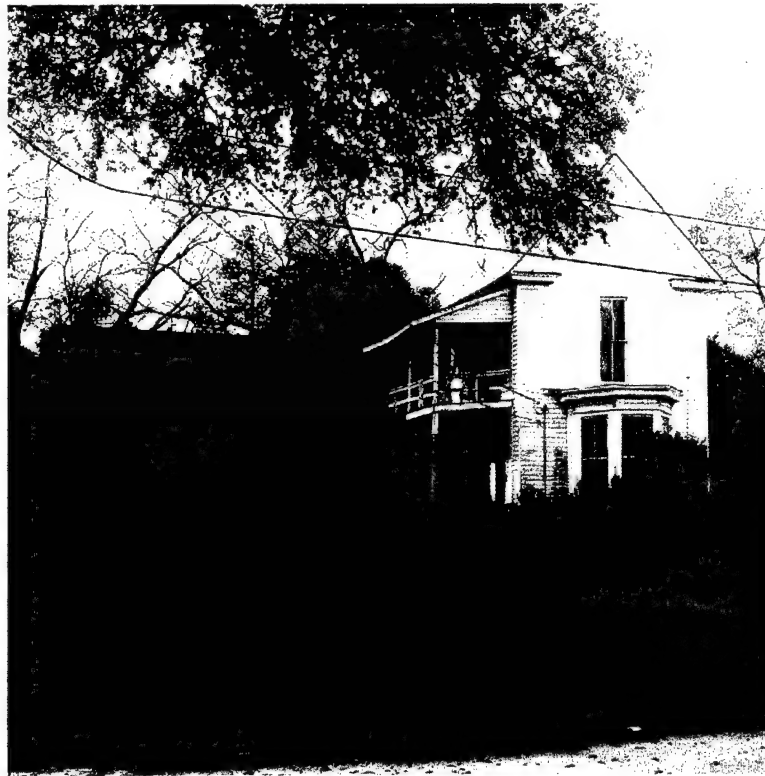
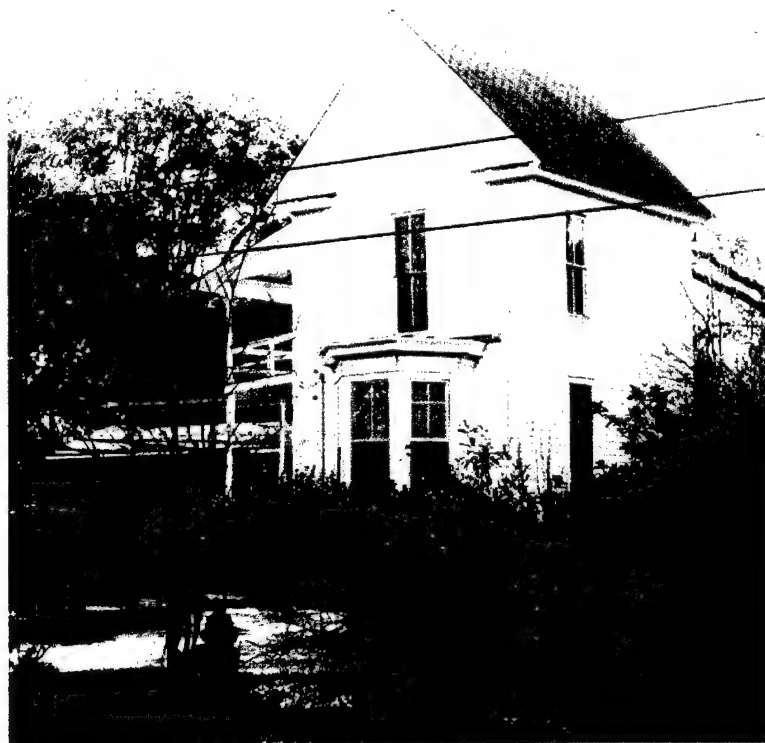
Figure 5. Laird House (site 061 195). Top: looking southwest (R11F8); Bottom: looking southeast.

Site 061 195 is the H. W. Laird House, located on Bryant Avenue (formerly Laura Street) at the intersection of Academy Street. The house was built in two phases. The oldest part of the house was built in 1867, and is a one story frame building with a side gable roof. A shed roof porch projects from below the front eave line, supported by simple wood posts and enclosed with insect screening. Originally, the facade was symmetrical, with a single door flanked on each side by single windows. The house rests on a brick pier foundation, and features an exterior brick chimney on the left side.

Site 061 195 has been altered with the addition of synthetic siding. Despite this alteration, the building continues to convey its historical association with Captain H. W. Laird and his family, who were significant in the history of the City of Geneva. The house is one of the earliest remaining buildings from the City of Geneva after its relocation from the junction of the Pea and Choctawhatchee Rivers. We recommend site 061 195 eligible for the NRHP under Criterion A (Exploration/Settlement).

Site 061 195 is located approximately 60 meters (200 feet) north of the current edge of the levee. Figure 7 shows the location of site 061 195 on a Geneva County ownership map. Current designs call for the proposed new right-of-way of the levee to extend

approximately 15 meters (50 feet) north of the current edge. As currently designed, the proposed Geneva levee rehabilitation project will not affect historic property 061 195.

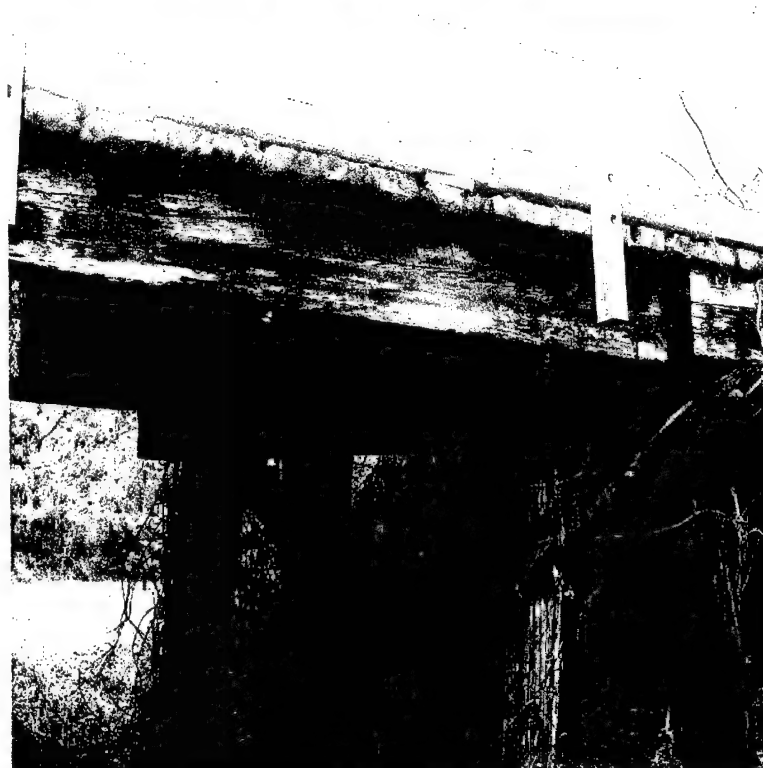
Figure 8. The L&N Railroad Bridge, site 061 245. Top: looking northwest;
Bottom: detail looking northeast.

The Louisville & Nashville Railroad completed its line into Geneva in 1901, and at that time constructed several associated properties including a depot, a platform, a powerhouse, and this overhead crossing. Figure 6 (above) shows site 061 245 and the other associated buildings and structures in 1902. Only the overhead crossing remains.

Site 061 245 has retained good integrity. While the rails were removed in approximately 1985 and the path of the railroad converted for use as a walking trail, the structure of the bridge remains intact. A new approach to the bridge from the east was created in 1938 when the levee was constructed, but the bridge apparently was not altered, as the original timber supports and frame remain. Moreover, site 061 245 is the only remaining artifact from the L&N Railroad in the City of Geneva, and it is also a good example of timber bridge construction. We recommend site 061 245 eligible for the NRHP under Criteria A (Transportation) and C (Engineering).

Site 061 245 is located approximately 60 meters (200 feet) west of the current edge of the levee. Figure 10 shows the location of site 061 195 on a Geneva County ownership map. Current designs call for the proposed new right-of-way of the levee to extend approximately 15 meters (50 feet) west of the current edge. As currently designed, the proposed Geneva levee rehabilitation project will not affect historic property 061 245.

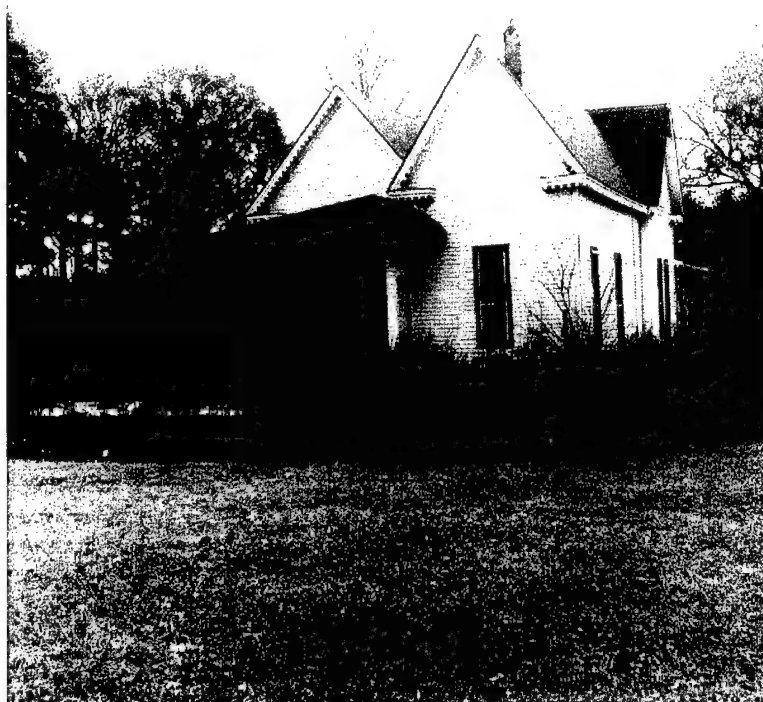
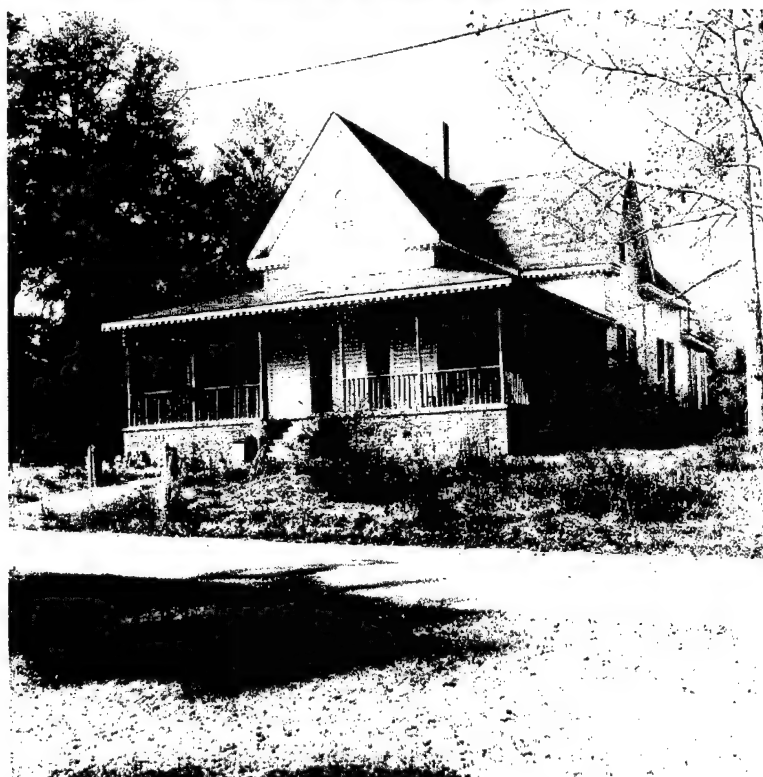
Figure 11. The Wallace House, site 061 037. Top: looking northwest; Bottom: looking southeast (rear).

The house was built by the Wallace family, who were Jewish merchants in Geneva. Site 061 037 has been altered with the replacement of the original porch foundation with brick, and new porch supports, windows, and doors. It is possible that the entire porch is new. While the house has an interesting history and has distinctive architectural features, its integrity has been compromised. We recommend site 061 037 not eligible for the NRHP.

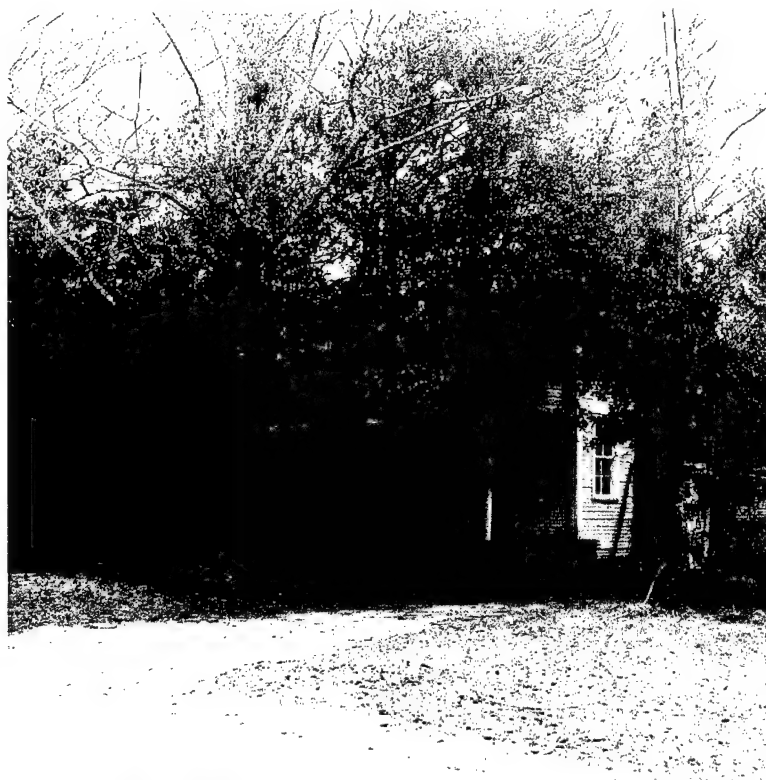
Figure 12. Site 061 187. Top: looking northwest; Bottom: looking east.

Site 061 187 is a one story frame house located on West Water Avenue (see Figure 1). Built in approximately 1900, the house features a side gable roof with a cross gable extension on the rear. The facade is symmetrical, with a central single door with side lights flanked on each side by a single door and a single four-over-four window. A shed roof porch

projects from beneath the main roof eave, supported by simple wood posts. There is an exterior brick chimney at each gable end. Figure 12 presents views of site 061 187.

According to Mary Clayton Powell, the house may have been used by a Dr. Corley, a self-proclaimed faith healer who attracted a number of followers in the 1930s (Mary Clayton Powell, personal communication, 2002). However, this information has not been substantiated. Site 061 187 has retained fair to good integrity and is in fair to good condition. Despite a possible historical tie, site 061 187 lacks additional historical or architectural significance and is recommended not eligible for the NRHP.

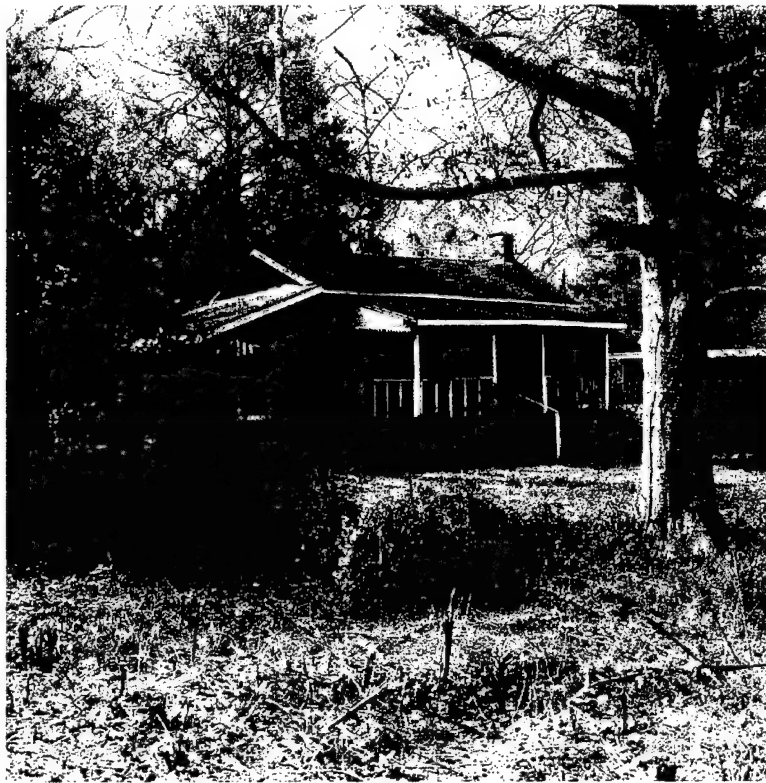
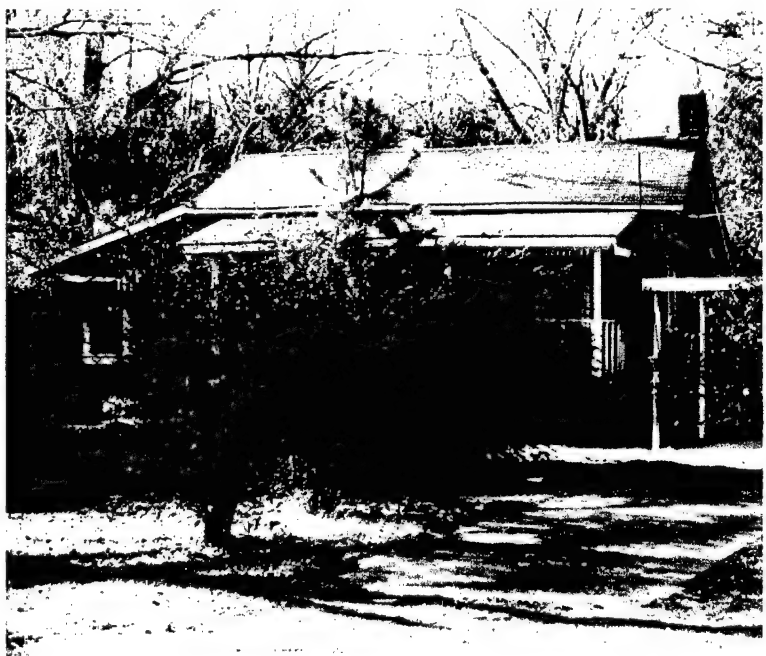
Figure 13. Site 061 197. Top: looking southwest; Bottom: looking southwest.

Site 061 197 is a small one story frame house located on Westville Avenue at the corner of South Commerce Street (see Figure 1). Built in approximately 1910, the house features a four bay facade with two off-center single doors flanked on each side by single four-over-four windows, surmounted by a side gable roof. A shed roof porch projects from beneath the main roof eave, supported by simple wood posts and a simple wood balustrade. There is a shed roof addition on the left side, and an exterior brick chimney on the right side. The house is clad in faux brick asphalt shingle siding. Figure 13 presents views of site 061 197.

Site 061 197 has been altered with the addition of synthetic siding, the replacement of the original porch, and a one room addition on the left side. Site 061 197 lacks historical or architectural distinction and is recommended not eligible for the NRHP.

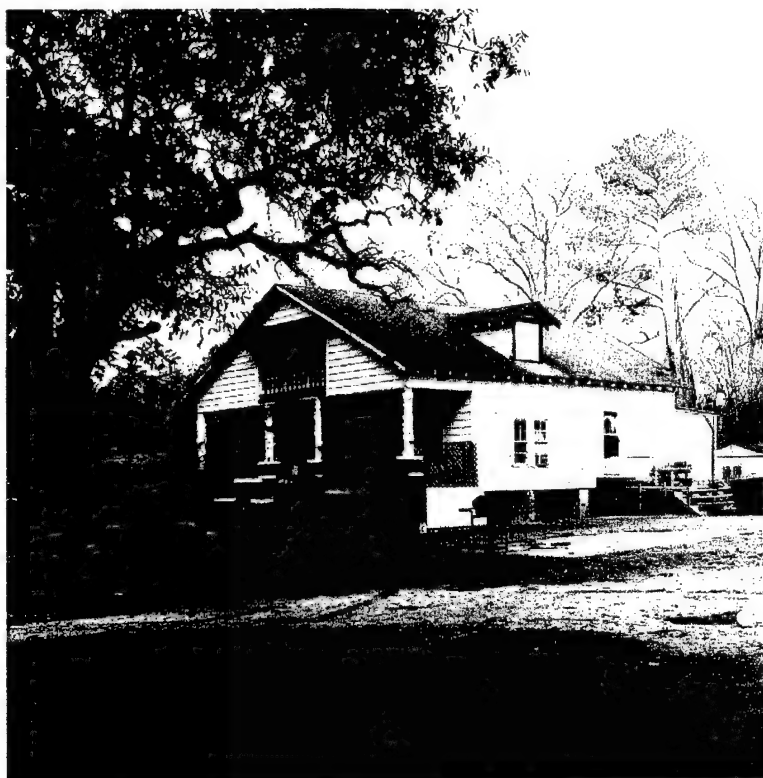
Figure 14. Site 061 198. Top: looking northeast; Bottom: looking southeast.

Site 061 198 has been altered with the addition of synthetic siding on the main house and faux brick asphalt shingle siding surrounding the door, and the creation of a window in the main roof gable. Despite the interest of its architectural details, site 061 198 lacks additional historical or architectural distinction and is recommended not eligible for the NRHP.

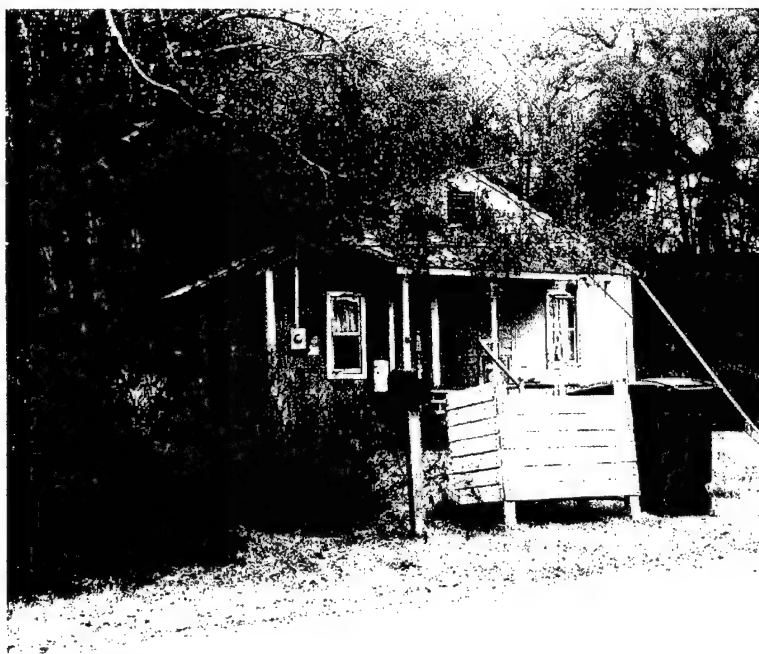
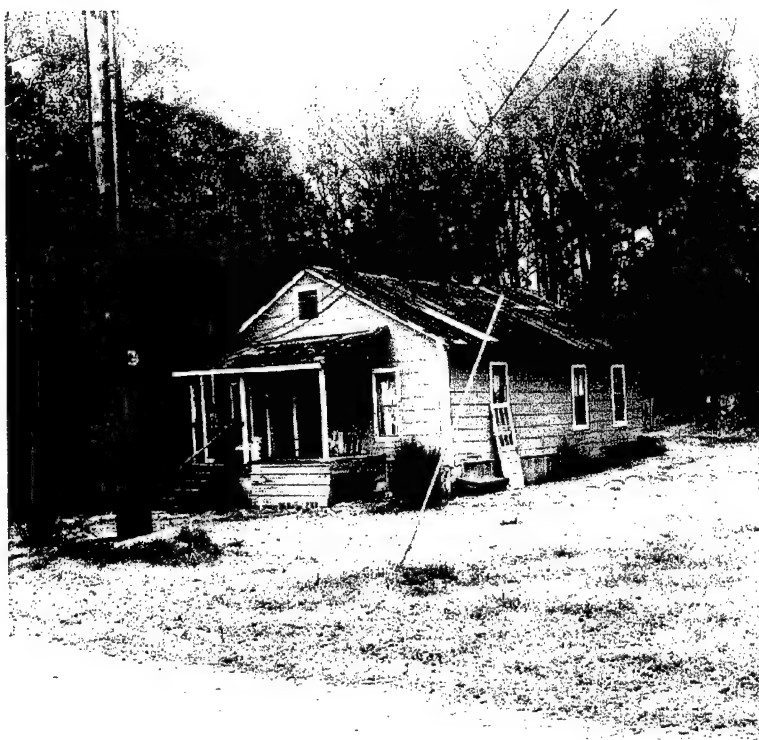
Figure 16. Site 061 243. Top: looking northeast; Bottom: looking southeast.

1940. Originally, the house had a four bay facade, with two single doors flanked on each side by a single window. One of the original doors has since been covered. A shed roof porch projects from beneath the front gable, supported by simple wood posts. Figure 16 presents views of site 061 243.

Site 061 243 has been modified with the addition of synthetic siding, the removal of one of the original doors, and the replacement of the original windows and door. Site 061 243 lacks historical or architectural distinction and is recommended not eligible for the NRHP.

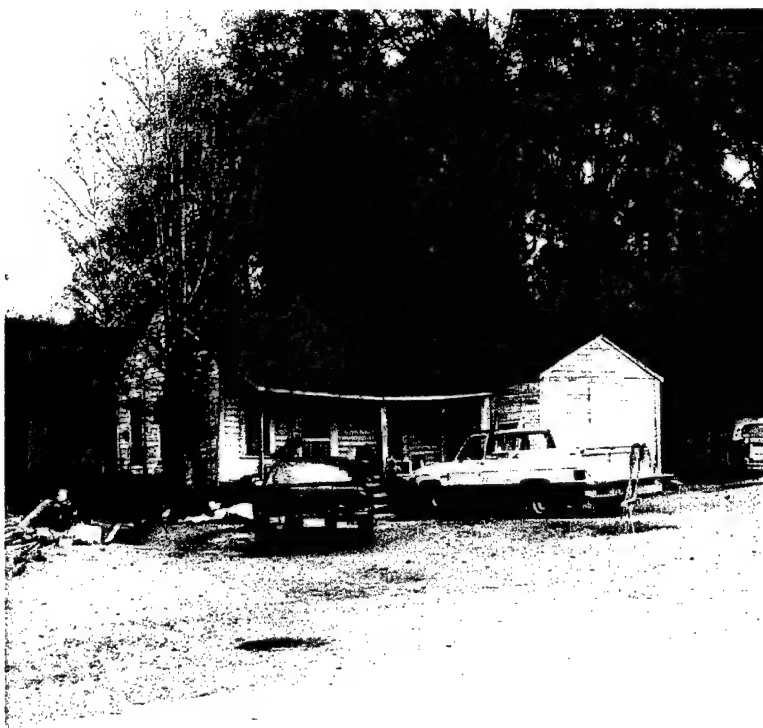
Figure 17. Site 061 244. Top: looking southeast; Bottom: looking northeast.

Site 061 244 has been altered with the reconfiguration of the original facade. The house is in fair condition. Site 061 244 lacks architectural or historical distinction and is recommended not eligible for the NRHP.

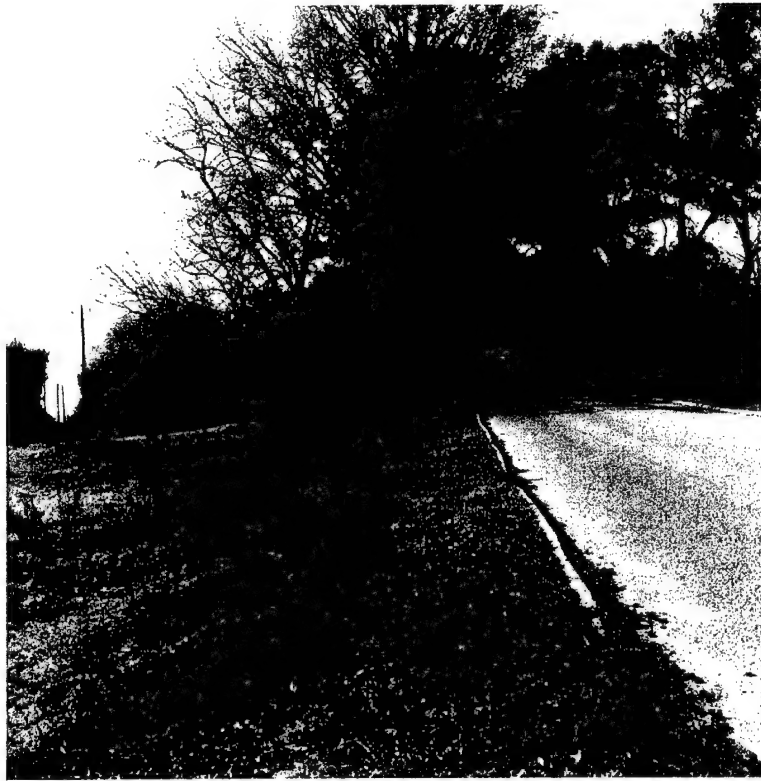
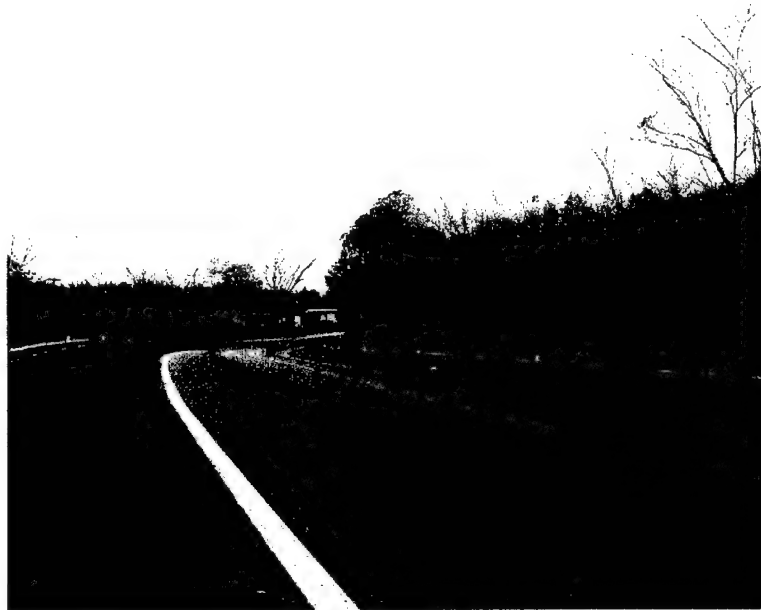
Figure 19. Geneva Levee, site 061 247. Top: Westville Ave crossing, looking west;
Bottom: AL Route 27 crossing, looking northeast.

The levee varies in height, rising from grade to a maximum height of approximately 7.5 meters (25 feet), and in width, with a maximum width of approximately 20 meters (65 feet). Since it was constructed, the levee has become densely overgrown with trees (Figure 21).

As noted above, the levee has retained fair to good integrity. The most significant alteration has been the replacement of the original flap gates with manually operated screw

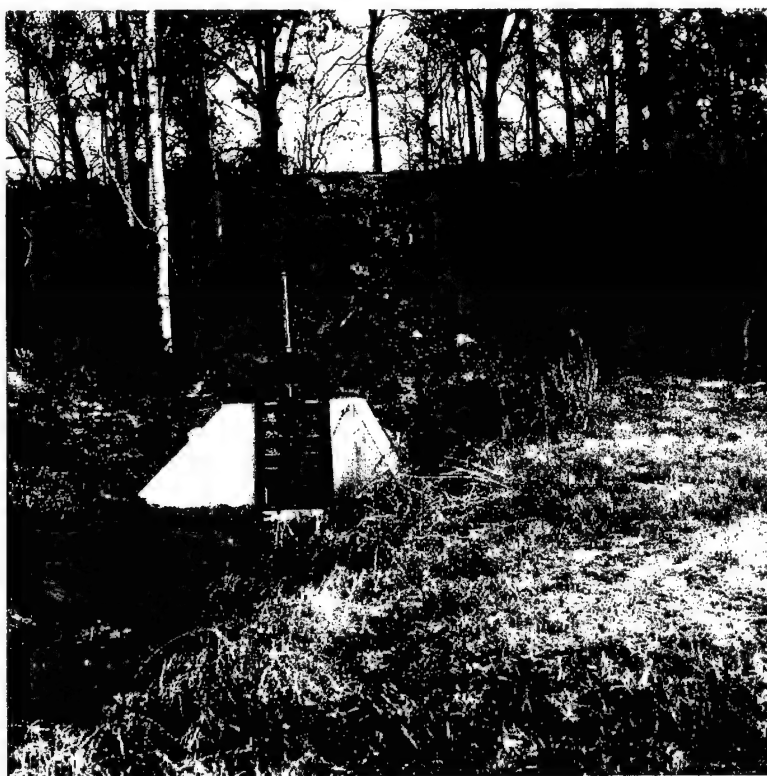
Figure 22. Geneva Levee, site 061 247, modern screw gates. Top: drainage structure 6, looking southwest; Bottom: drainage structure 3, looking east.

gates (Figure 22). In addition, the levee is now largely overgrown with trees. Despite having retained fair to good integrity, the Geneva Levee has only modest historical significance. The levee presents few distinctive technical features such as gates or pumps, and has been tested only minimally in the prevention of floods. Therefore we recommend site 061 247 not eligible for the NRHP.

The levee system at Geneva has seen few improvements since it was constructed in 1938; the original flap gates have been replaced with manually operated screw gates. The USACE has conducted several studies of the Choctawhatchee River basin since the 1930s, though none addressed the Geneva levee directly until the 1960s. At this time, the USACE considered additions to the existing levees at Elba and Geneva, Alabama and Caryville, Florida, along with navigation improvements to the river and its tributaries. Only one improvement, a headwater impoundment at Arifton was found “to offer any potential for economic justification” (USACE 1984:4). In 1970, the USACE prepared a reconnaissance report which concluded that the Geneva levee should be rehabilitated (USACE 1984). The report included no specifics, and the plan was never authorized or funded.
